## Special Service Project

SSP00-57-01

RIGHT WING SPAR CAP STIFFENER INSPECTION

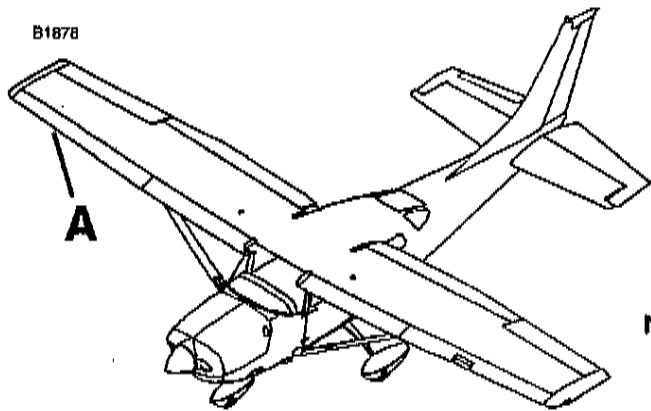
Figure 1. Wing Spar Inspection (Sheet 1)

Some right wings may have been manufactured with a spar cap stiffener made of 0.100 inch thick material instead of 0.125 inch thick material required for float plane operations.

- B. Remove the 620AB Aileron Bellcrank Access Plate. (Refer to the Model 206H/T206H Maintenance Manual, Chapter 6, Dimensions and Areas.)
  - C. (Refer to Figure 1, Sheet 1, Detail A) Locate the end of the 1222005-12 Stiffener by looking up through the aileron bellcrank access hole.

**NOTE:** PLACE THE FABRICATED (0.125 INCH THICK) ALUMINUM GAGE AGAINST THE END OF THE 1222005-12 STIFFENER AND COMPARE.

- (2) If the stiffener is thinner than the 0.125 inch feeler gauge, further disposition will be coordinated through Cessna Propeller Aircraft Product Support.
